Pinholes in Sensors for RunIIb Silicon Detector

By: Julia Novak

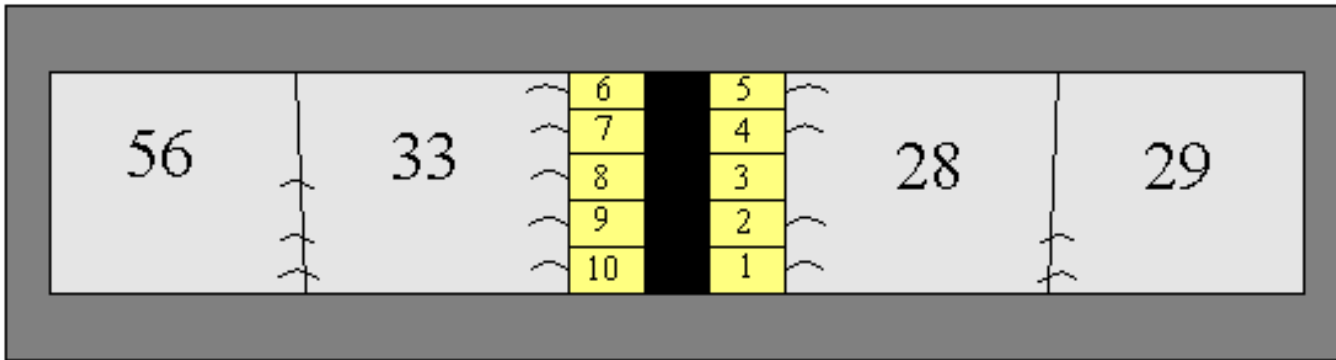
Sensors 28, 29, 33, and 56

- Did not find pinholes in sensors 29 and 56
 - Not bonded to chip
- Did not find same pinhole in sensor 28
 - Pinhole at 214 not detected
 - Pinhole found in strip 26 on chip 6 and 111 on chip 1
- New pinholes discovered in sensor 33
 - No pinholes previously detected

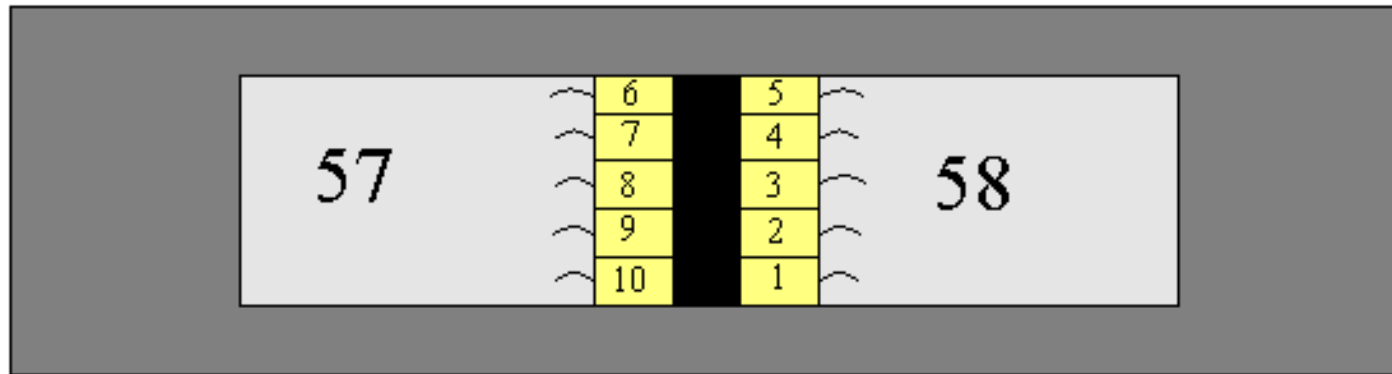
Sensors 57 and 58

- Not connected channel discovered in sensor 57
 - No pinholes previously detected
- Two not connected channels detected in sensor 58
 - No pinholes previously detected

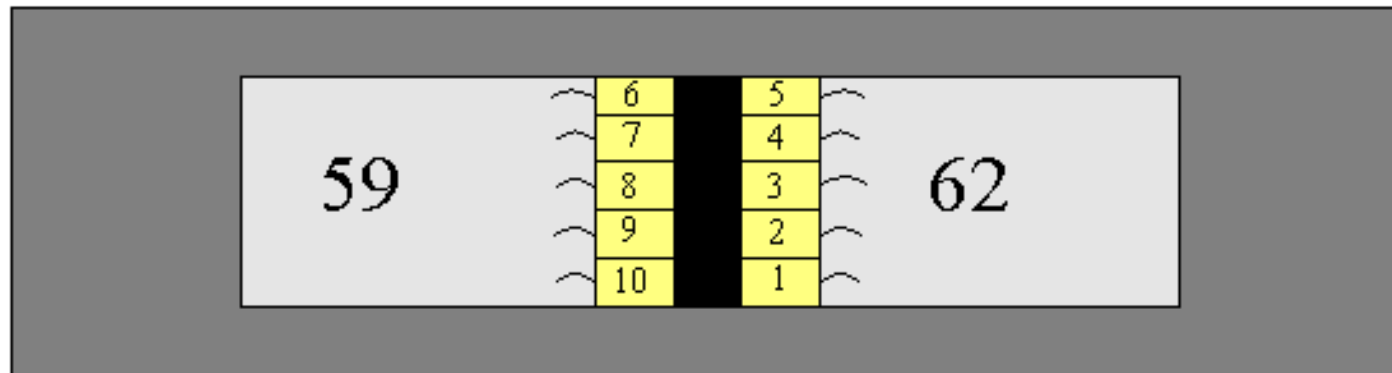
Sensors 59 and 62

- Did not find same pinhole in 59
 - Pinhole on strip 40 was not found
 - Channel 28 has higher noise & pedestal
- 62 in compliance with previous tests
 - No pinholes detected

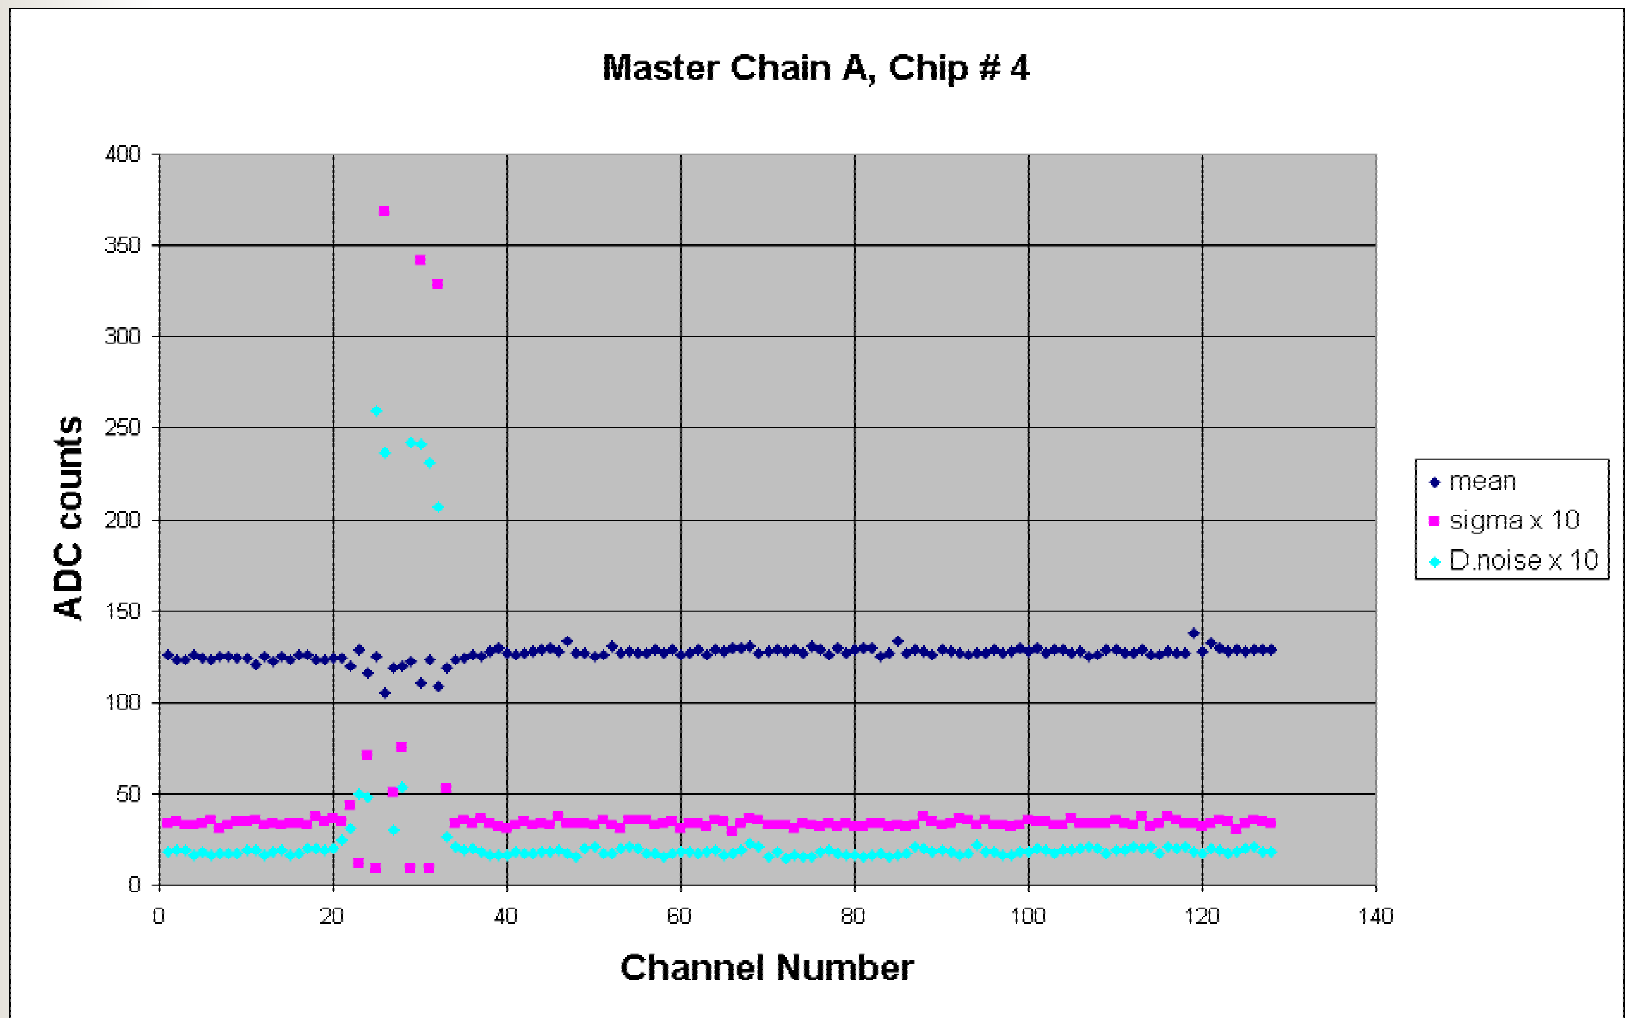
10x10 Stereo Module (Hybrid #1)

- Possible chip malfunction
 - Source of noise could not be masked
 - Which chip?
 - Chip 4
 - Which modules are affected?
 - All tested 10x10 modules
 - Are the malfunctions consistent?
 - Malfunction observed between channels 20 and 40 on stereo module
 - Malfunction observed between channels 80-100 on multiple axial modules
- Possible noise pick-up from cable (needs to be checked)
